### In the United States District Court For the Southern District of Texas Galveston Division

Jay Rivera	§	
Plaintiff,	§	3:17-cv-111
	§	
<b>v.</b>	§	
	§	9(H) Admiralty
Kirby Offshore Marine, LLC	§	
In personam	§	
M.V. Tarpon	§	
In Rem	§

# <u>Plaintiff Jay Rivera's</u> <u>Second Amended Complaint</u>

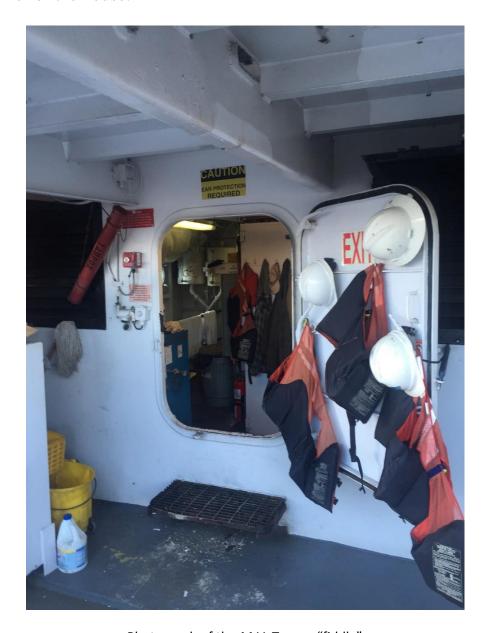
- 12. Capt. Rivera was then escorted to the rear of the house of the *M.V. Tarpon*, where he was required to enter the interior of the *M.V. Tarpon* by climbing over a raised bulkhead and through a watertight door. At this time, the escort went ahead of Capt. Rivera into the interior of the wheelhouse, and left him behind—unescorted. A

true and correct photograph of the entrance to the *M.V. Tarpon's* house, or "fiddly" is shown below as well as a photograph of the bulkhead and engine room access hatch on the interior of the house.

Photograph of the M.V. Tarpon "fiddly"

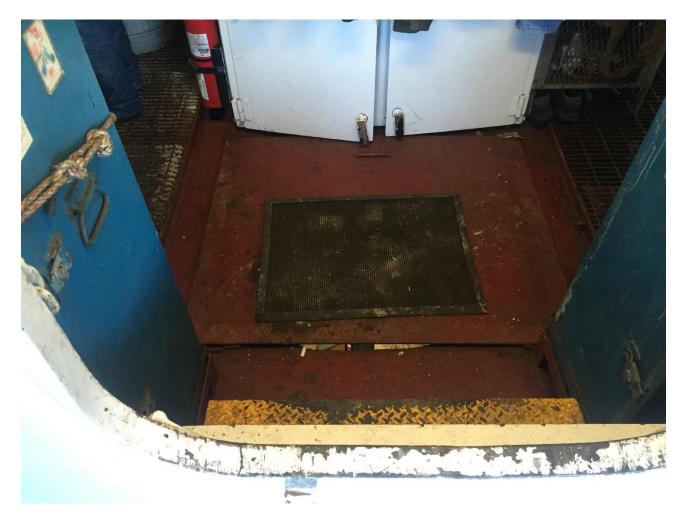
Photograph of the bulkhead and engine room access hatch

- 13. As Capt. Rivera climbed over the bulkhead, making use of the exterior and interior steps, he then stepped down onto the engine room access hatch.
- 14. Unbeknownst to Capt. Rivera, the edges of the engine room access hatch, which were not marked with any type of yellow tape or paint warning of its hazard, were raised from the deck approximately one to two inches. The AB also failed to warn Capt. Rivera of this hazard and was not present to prevent him from falling or to assist him over the watertight door/bulkhead.

- 15. As Capt. Rivera stepped onto the engine room access hatch, his left foot landed on the raised outer edge of the engine room access hatch and his foot rolled off that raised edge causing him to fall to the deck. Capt. Rivera immediately felt a pop in his left foot but he believed he had simply rolled his ankle.

- 34. Additionally, Kirby failed to sufficiently mark the hazard of the raised engine room access hatch cover with contrasting paint or yellow tape which is also the industry standard.

- 42. The *M.V. Tarpon* was unseaworthy as that term is understood at law as the engine room access hatch cover was defectively designed, or engineered, or marked in such a way to not appraise anyone transiting it of its inherent danger, creating an unsafe condition aboard the vessel. Furthermore, this unmarked and hazardous condition created a tripping hazard comprising an unseaworthy condition of the *M.V. Tarpon*. *See Mitchell v. Trawler Racer, Inc.*, 362 U.S. 539 (1960).

- 43. Coupled with the defective access hatch is the lack of any handrails sufficient for anyone to use to stabilize themselves upon entering the house of the *M.V. Tarpon*,

and therefore compounding the defective access hatch.
